TECHNICAL NOTE 3275

INVESTIGATION OF THE EFFECT OF IMPACT DAMAGE ON FATIGUE  
STRENGTH OF JET-ENGINE COMPRESSOR ROTOR BLADES

By Albert Kaufman and André J. Meyer, Jr.

Lewis Flight Propulsion Laboratory  
Cleveland, Ohio

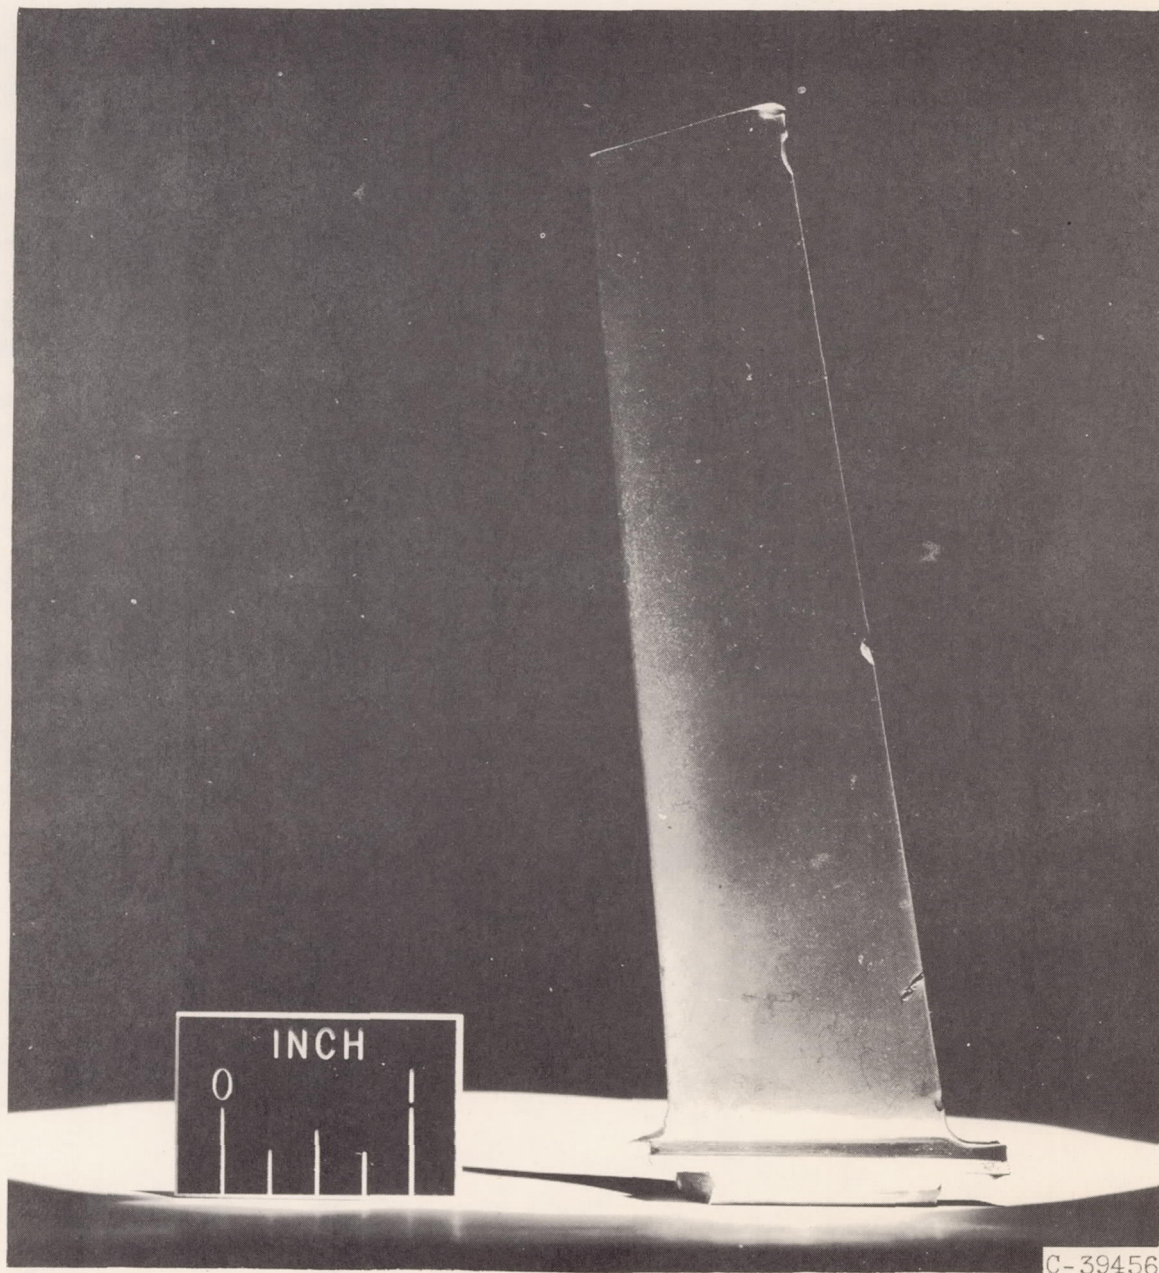
C-39456

Forty first-stage compressor blades which had been damaged to some extent were removed from the rotor and used for this investigation. One of the blades is shown in figure 1; some were more and others were less severely damaged. The damage defects were distributed over the pressure surfaces and the leading and trailing edges of the airfoils. None of the blades suffered damage on the suction surface. In this report, breaks or tears in the surface of the metal are called nicks, whereas surface deformations without breaks are termed dents (fig. 2).

Figure 1. - Typical damaged blade.

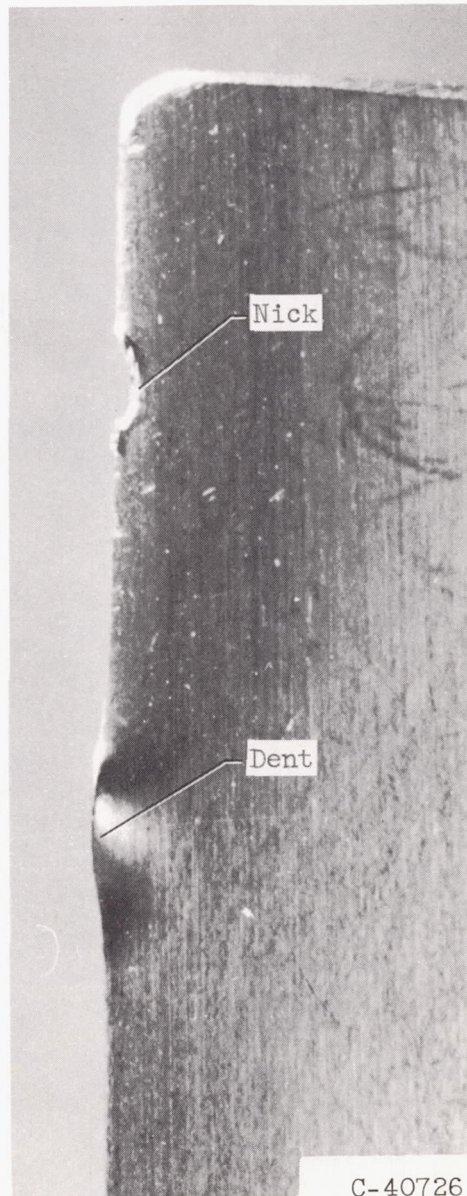
C-40726

Figure 2. - Types of blade damage.

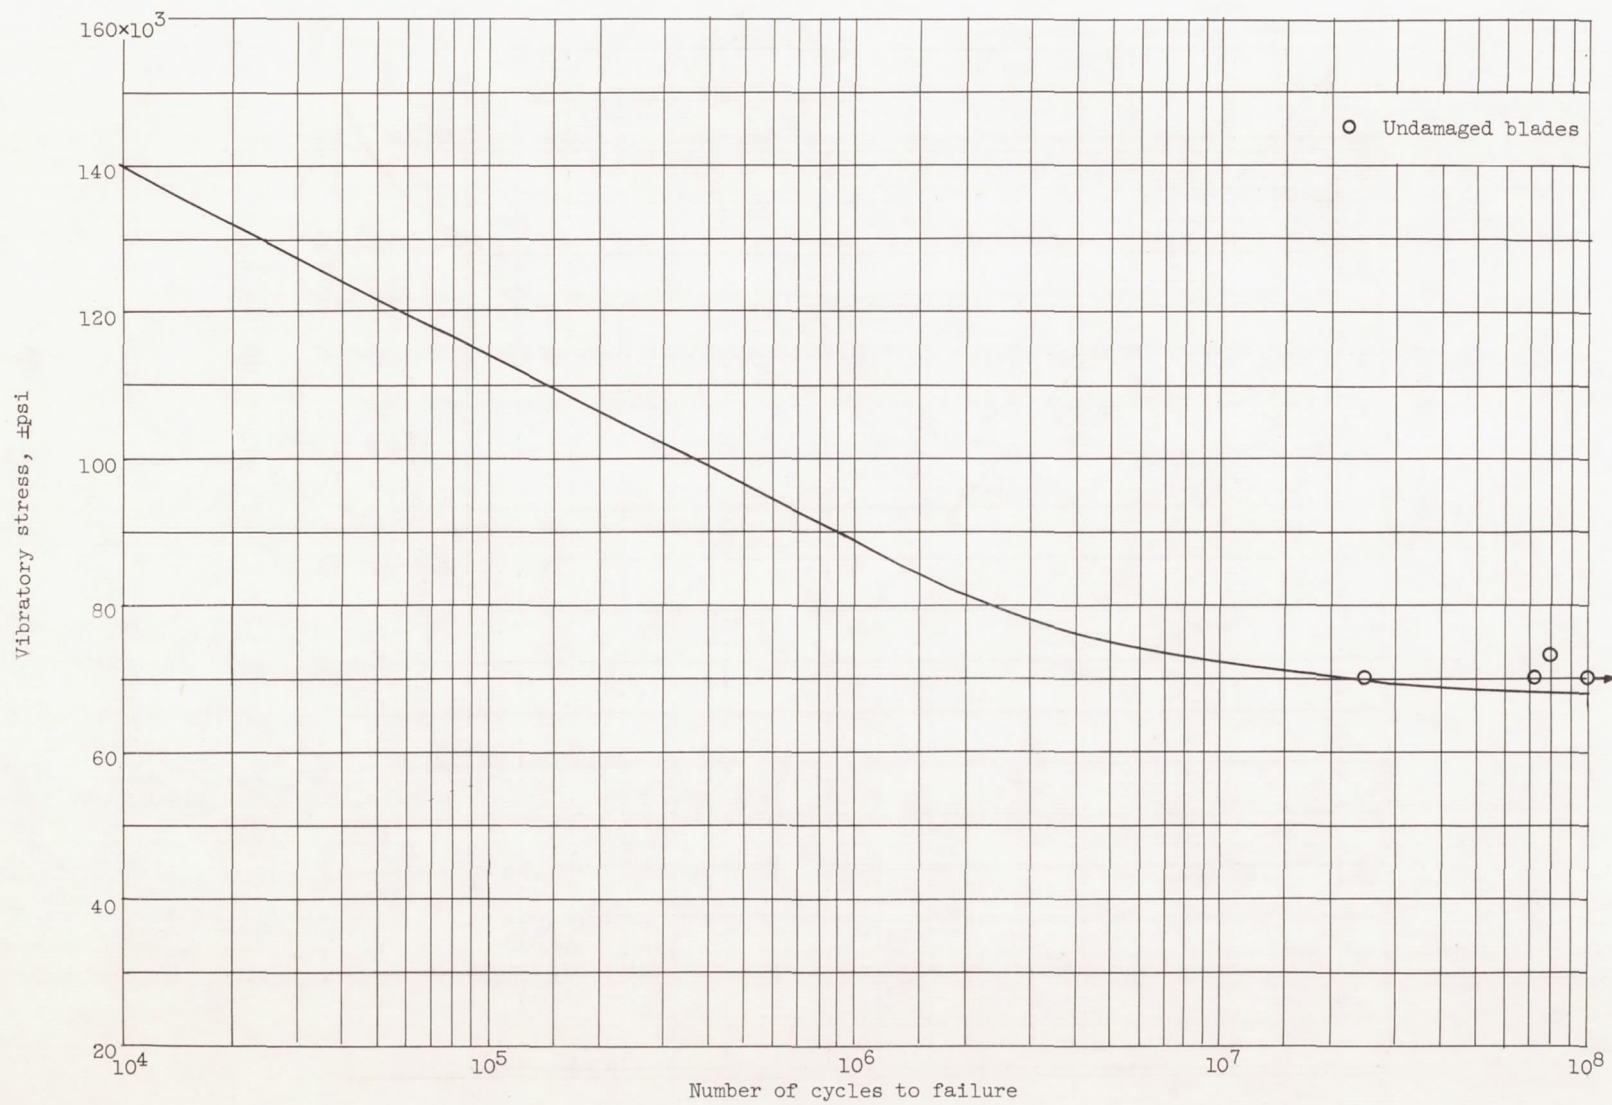
Figure 6. - Blade life as a function of vibratory stress.

The highest strength-reduction factor computed for these tests is 1.8 (fig. 6). This fact would indicate that if the vibratory stresses could be kept well below  $\pm 38,000$  psi ( $70,000$  psi/1.8) for all blades at

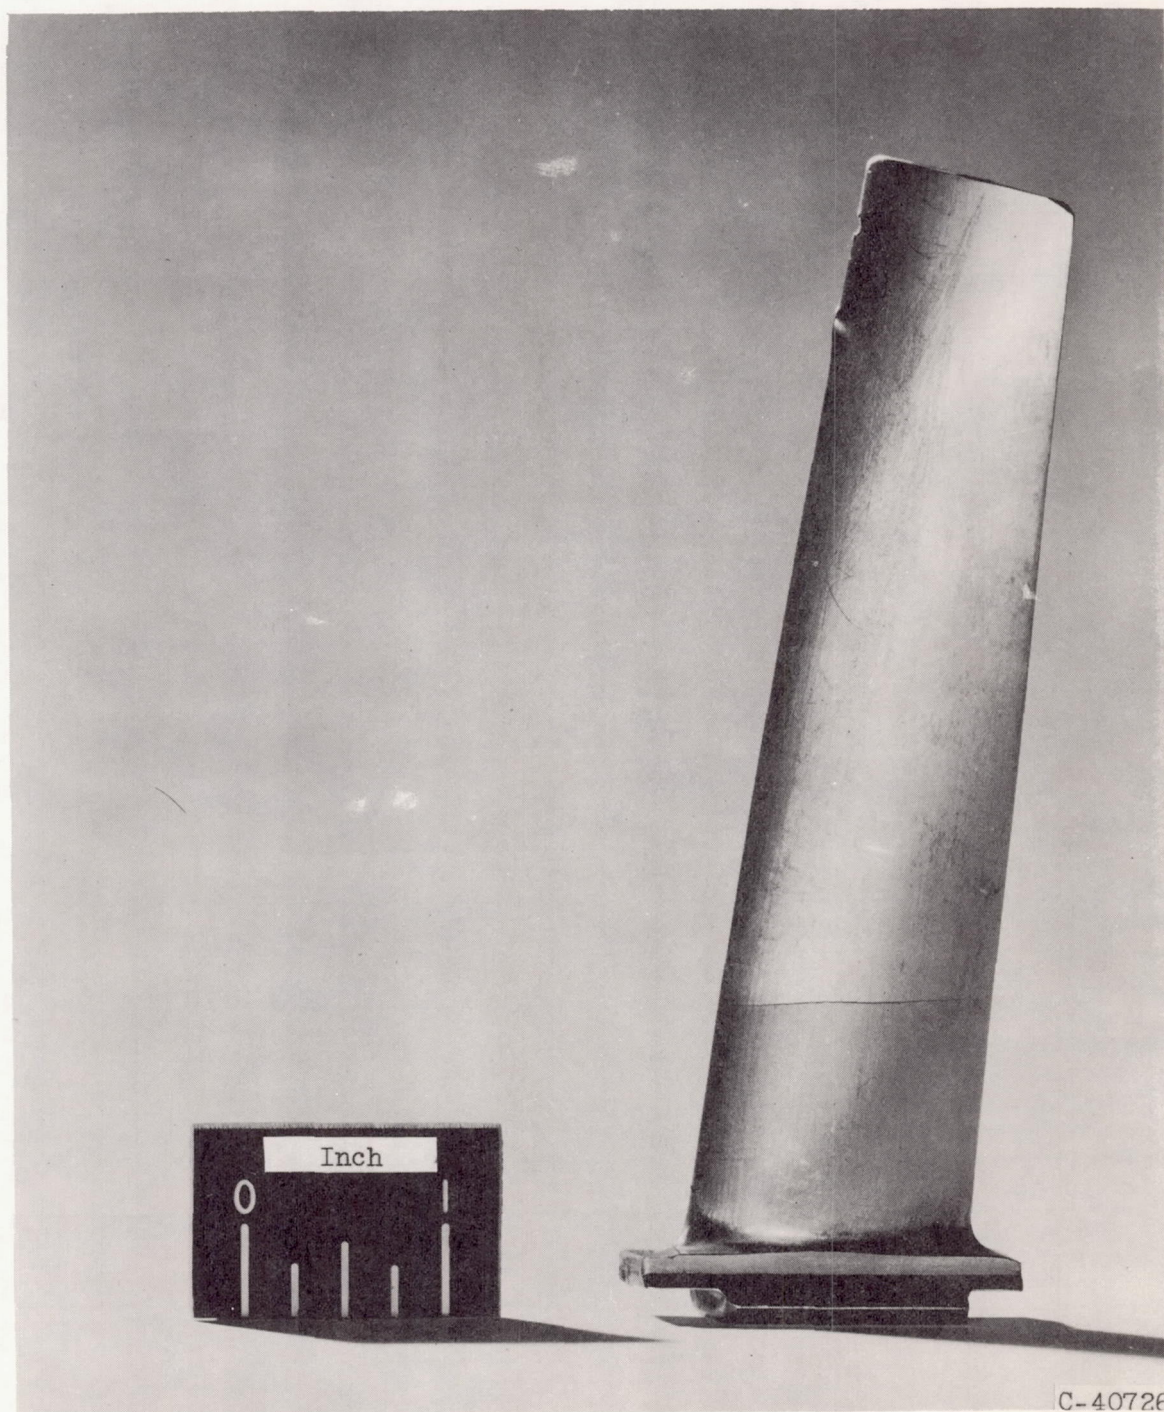
A blade, which except for the tip region was initially undamaged, was fatigue tested to failure to determine the failure location (fig. 8). In this blade the crack started at the thickest part of the section on the suction surface. In other undamaged blades, failure started at the leading edge. The spanwise location of failure, regardless of where the failure started chordwise, was always about 30 percent of the span from the base of the airfoil. Both the analytical and measured stress distributions of figure 7 satisfactorily predict the critical section, the experimental curve giving the closest prediction.

Figure 8. - Blade with failure in normal location.

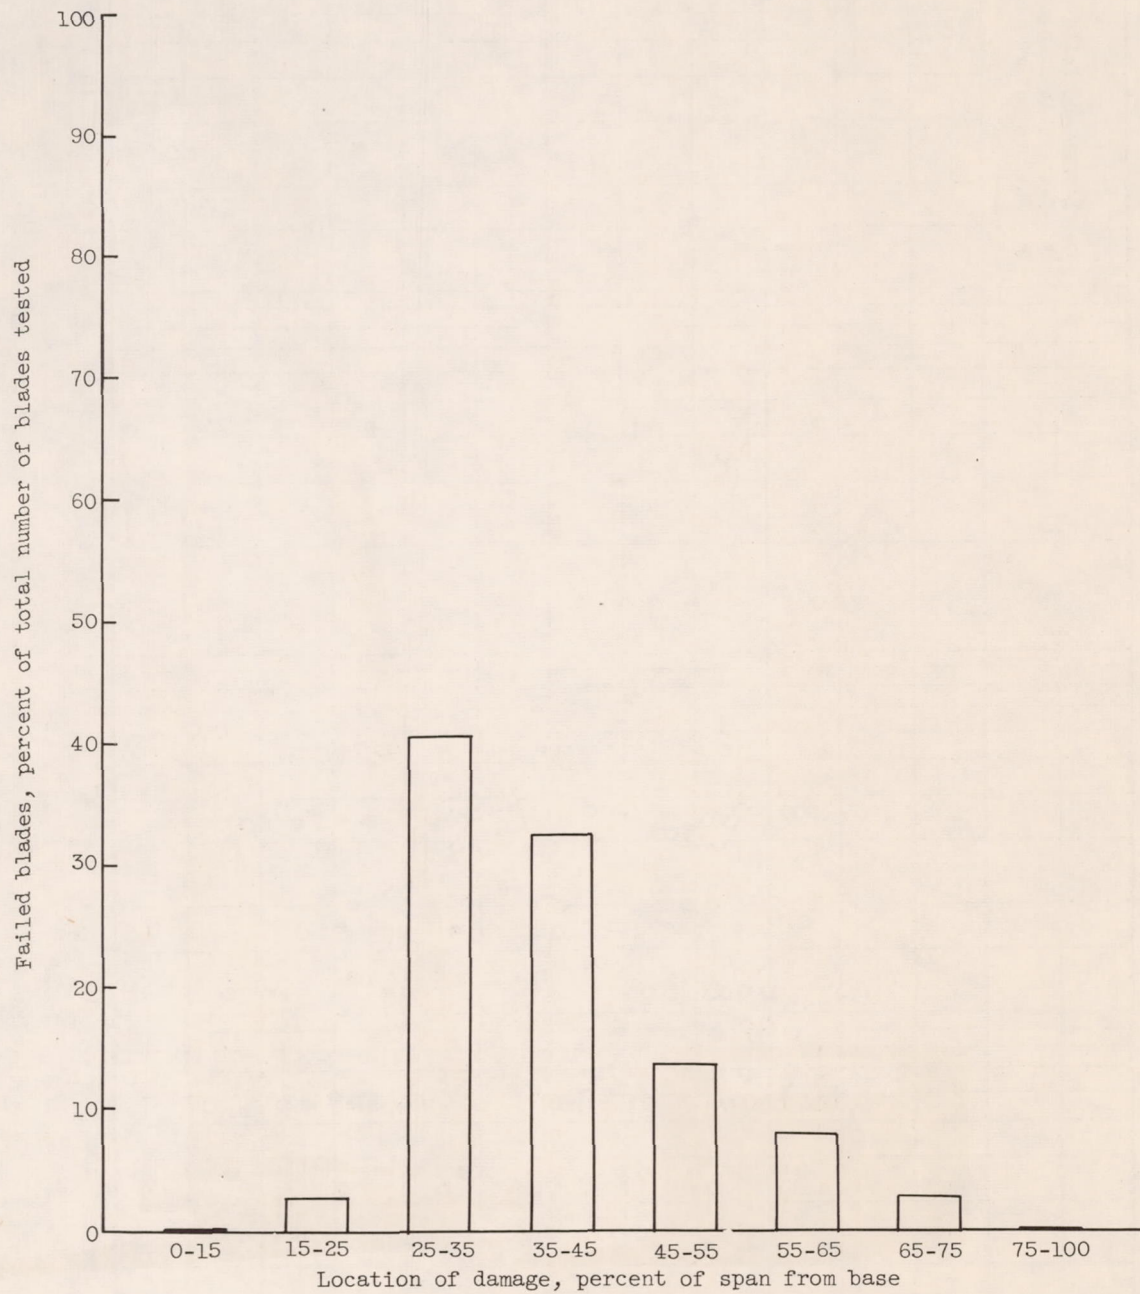
The results of the fatigue tests are shown in figure 9 in the form of a distribution of blade failures in various increments of span. The percent of blades that failed because of damage in each increment out of the total number of blades tested is shown by the lengths of the bars. The increment from 25 to 35 percent of the span from the base had the most sensitivity to damage. Over 40 percent of the total number of failures of damaged blades occurred in this small region. This was to be expected since the critical section falls within this span increment. The 35- to 45-percent-span region also showed a great sensitivity to damage.

Figure 9. - Percent of blades that failed out of total number of blades tested as function of failure location.

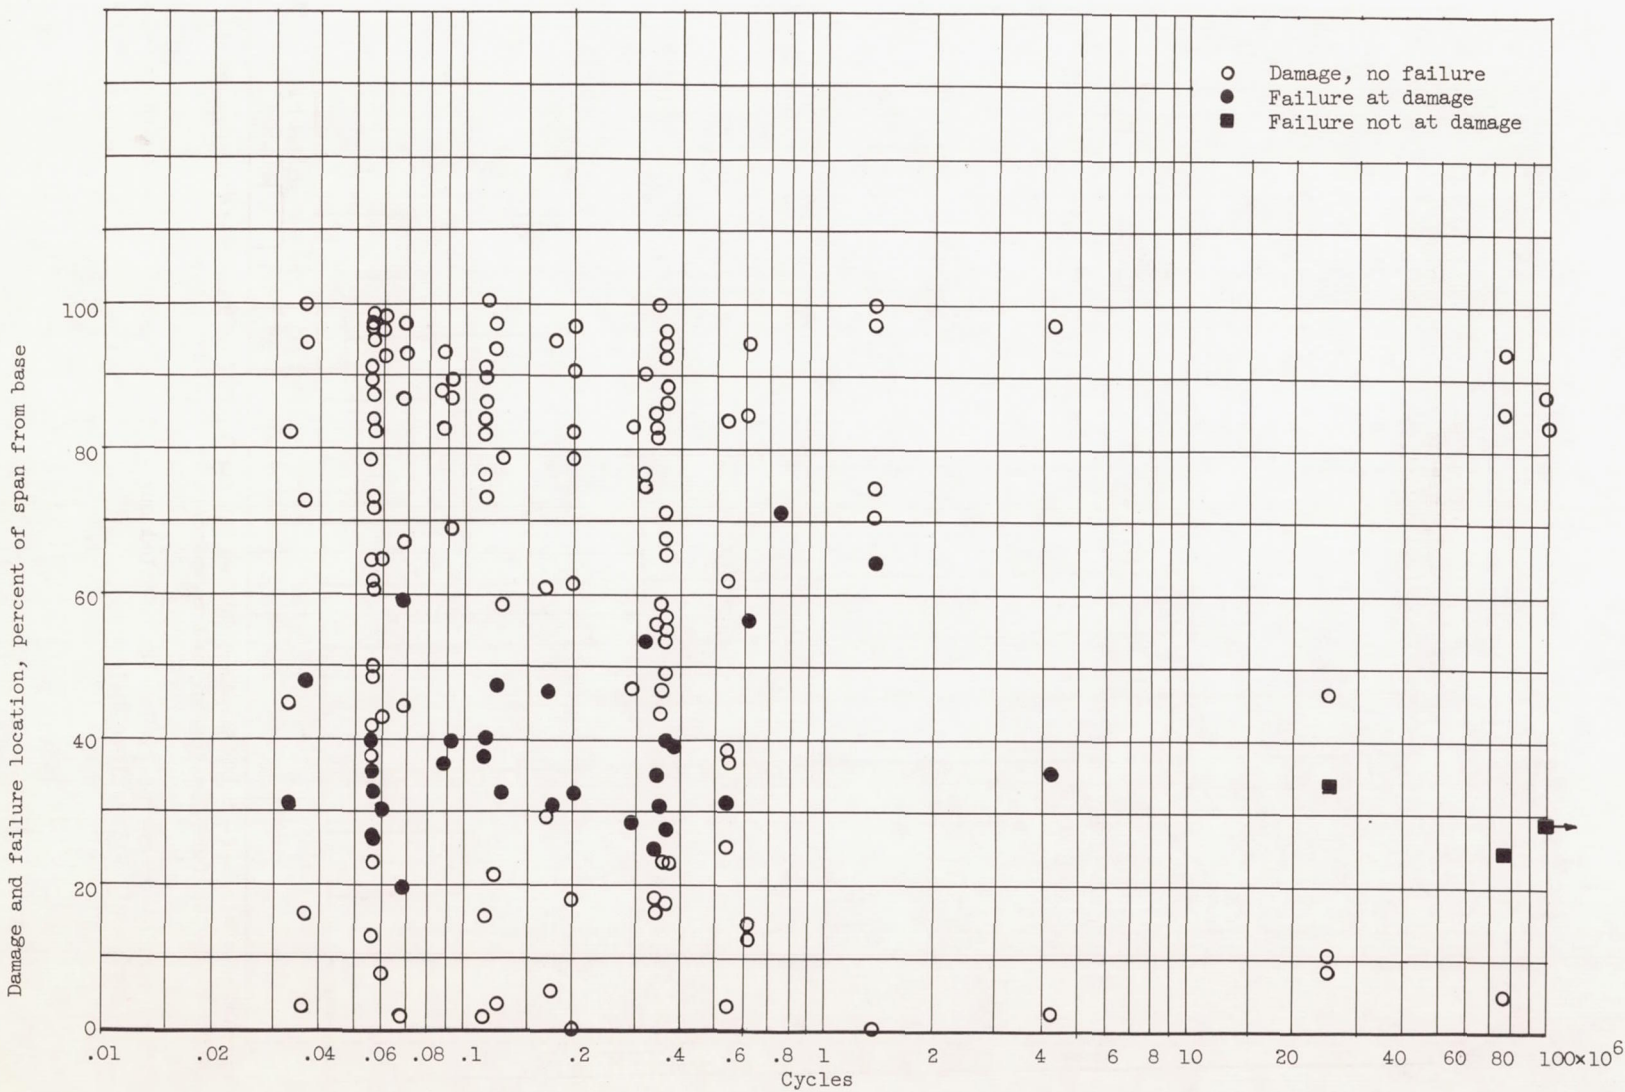
Neither the randomness nor the amount of blade damage is indicated by figure 9. Almost all of the blades suffered damage at locations other than where failure originated. There were also a few blades that failed at the 30-percent-span critical section at high numbers of cycles even though damage had been suffered at other locations. This can be seen in figure 10 where the solid circles denote damage defects where failure originated, the solid squares indicate where failure started when damage defects were not involved in the failure, and the open circles denote damage which did not cause failure.

From figure 10 it can be seen that nicks and dents were scattered over the whole span of the airfoil with the tip region having a greater concentration of damage. No failure occurred, however, because of defects located within 20 percent of the span from the base or within 25 percent of the span from the tip (in a total of almost half the airfoil span). Figure 10 also shows that there is a sharp reduction in the blade life whenever failure initiated at a damage defect.

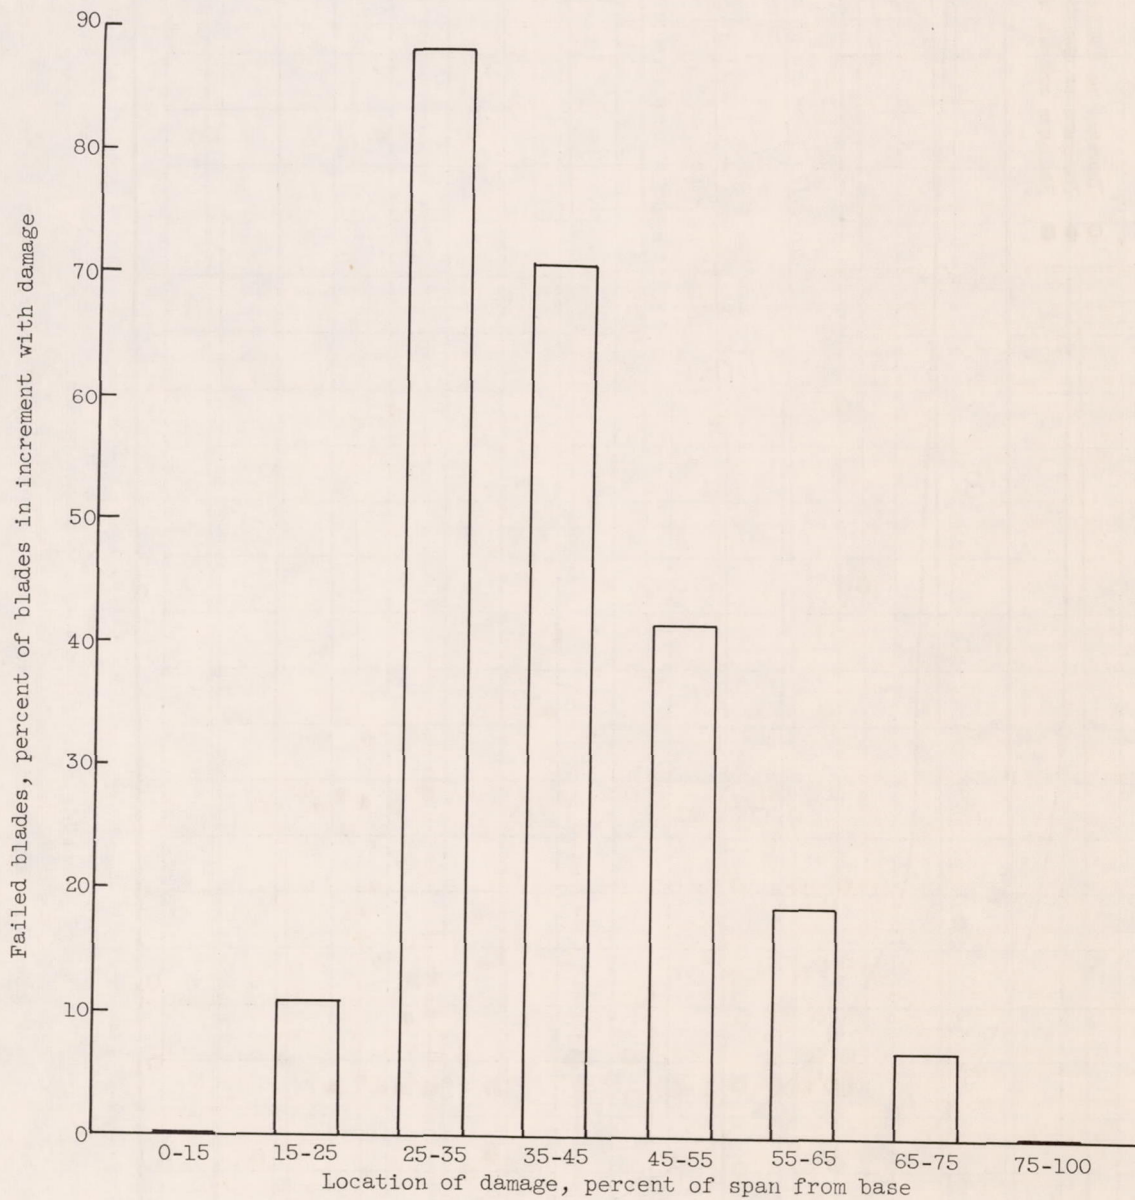
In figure 11 the airfoil span is divided into the same increments as in figure 9, but here the number of blades that failed in each increment is correlated with the number of blades that suffered damage in that increment rather than the total number of blades tested. Figure 11 is probably a fairer basis for evaluating the sensitivity of span location to damage than figure 9. From figure 11 it can be seen that in the 25- to 35-percent-span region nearly 90 percent of the blades damaged in that increment had failure originating at the damage. In the 35- to 45-percent-span region about 70 percent of the blades with damage in this region failed because of that damage.

Figure 11. - Percent of blades that failed out of number of blades in increment with damage as function of failure location.

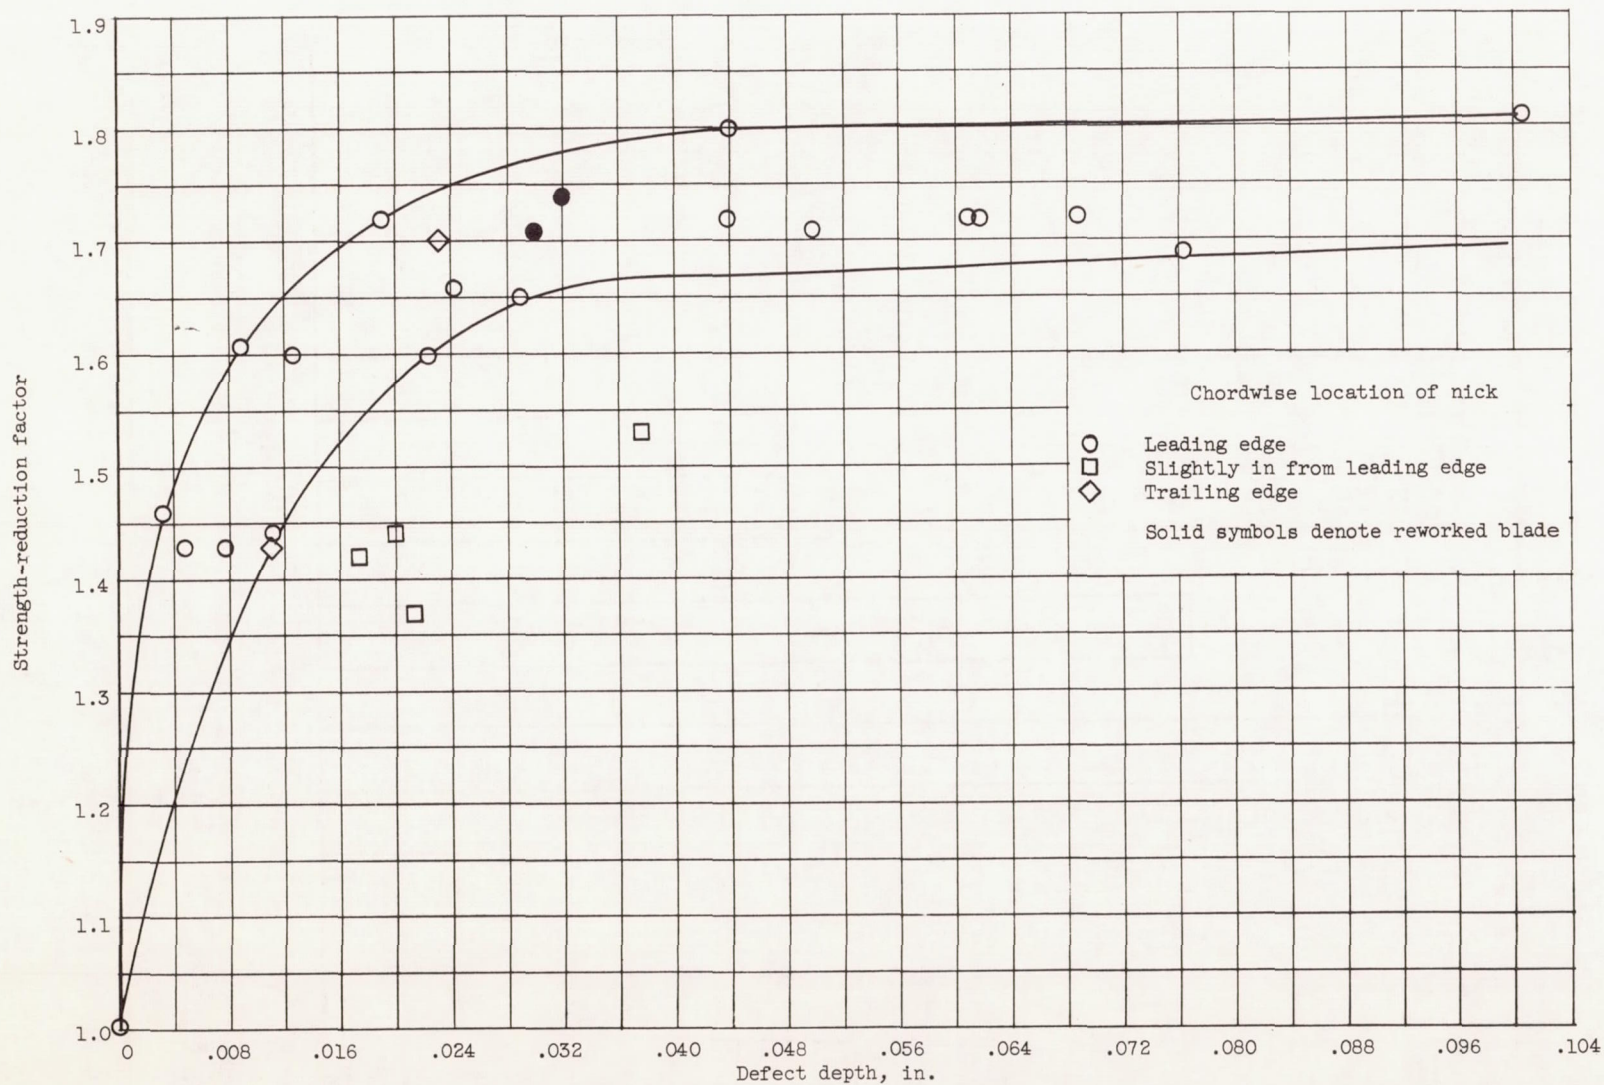
(a) Nicks in 20- to 45-percent-span region.

In figure 12(a) the results of the fatigue testing of blades which failed because of damage in the region between 20 and 45 percent of the span from the base are shown as a plot of the strength-reduction-factor parameter against the depth of the damage, which, owing to the jagged nature of some of the nicks, was the only pertinent dimension that could be determined. A band was drawn through the upper and lower limits of the data points for the failures due to edge nicks. In this region even the slightest nick sharply reduced the strength of the blade. Increasing the nick depth over  $1/32$  inch did not further reduce the blade strength appreciably. There is no difference between the effects of leading-edge and trailing-edge nicks. If the nick is even slightly in from the edge, the strength-reduction factor drops sharply. In no case where a nick was more than  $1/8$  inch from the edge did it result in premature blade failure. This must be qualified by the fact that no damage normally occurs on the suction surface of the blade. Conceivably, damage on the suction surface near the thickest part of the critical section could cause premature failure, since, for one of the undamaged blades (fig. 8), failure originated in that region. None of the blades investigated, however, showed impact damage on the suction surfaces due to foreign objects.

Additional conclusions can be drawn from the data presented in figure 12. First, very small nicks in the leading or trailing edge are extremely detrimental to blade life when located near the maximum-vibratory-stress region. For example, a 0.010-inch-deep nick which is relatively difficult to detect upon inspection without complete disassembly of the engine had an average strength-reduction factor of about 1.5 (fig. 12(a)). A blade normally vibrating at  $\pm 70,000$  psi would sustain about  $10^8$  cycles before failure. With a 0.010-inch-deep nick, a blade vibrating at the same nominal stress according to figure 6 would sustain only  $2.3 \times 10^5$  cycles before failure ( $70,000 \times 1.5 = 105,000$  psi effective stress). This constitutes a reduction in blade life of  $1000/2.3$ , or 435 to 1. When a blade with a 0.010-inch-deep nick vibrates at  $\pm 47,000$  psi ( $70,000/1.5$ ), it is possible to have a failure in  $10^8$  cycles while the undamaged blade can vibrate indefinitely near this stress level. The time to failure may be relatively short, because the average inlet-stage blades undergo  $10^6$  cycles per hour of vibration, and exit stages undergo as many as  $5 \times 10^6$  cycles per hour.

Figure 12. - Effect of defect depth and location on strength reduction.

Efforts to improve the strength of blades with sizeable nicks, while keeping the reworked or filed-out area to a minimum so as not to affect the blade aerodynamically, were unsuccessful. Nicks were filed in two undamaged blades at the critical section on the leading edge to a depth of about  $1/32$  inch. These nicks were then dressed out with files and emery cloth until no sharp edges were left, only a smoothly faired indentation on the leading edge. The results of fatigue testing these two blades are shown in figure 12(a). There is no discernable improvement in strength due to the reworking of these nicks.

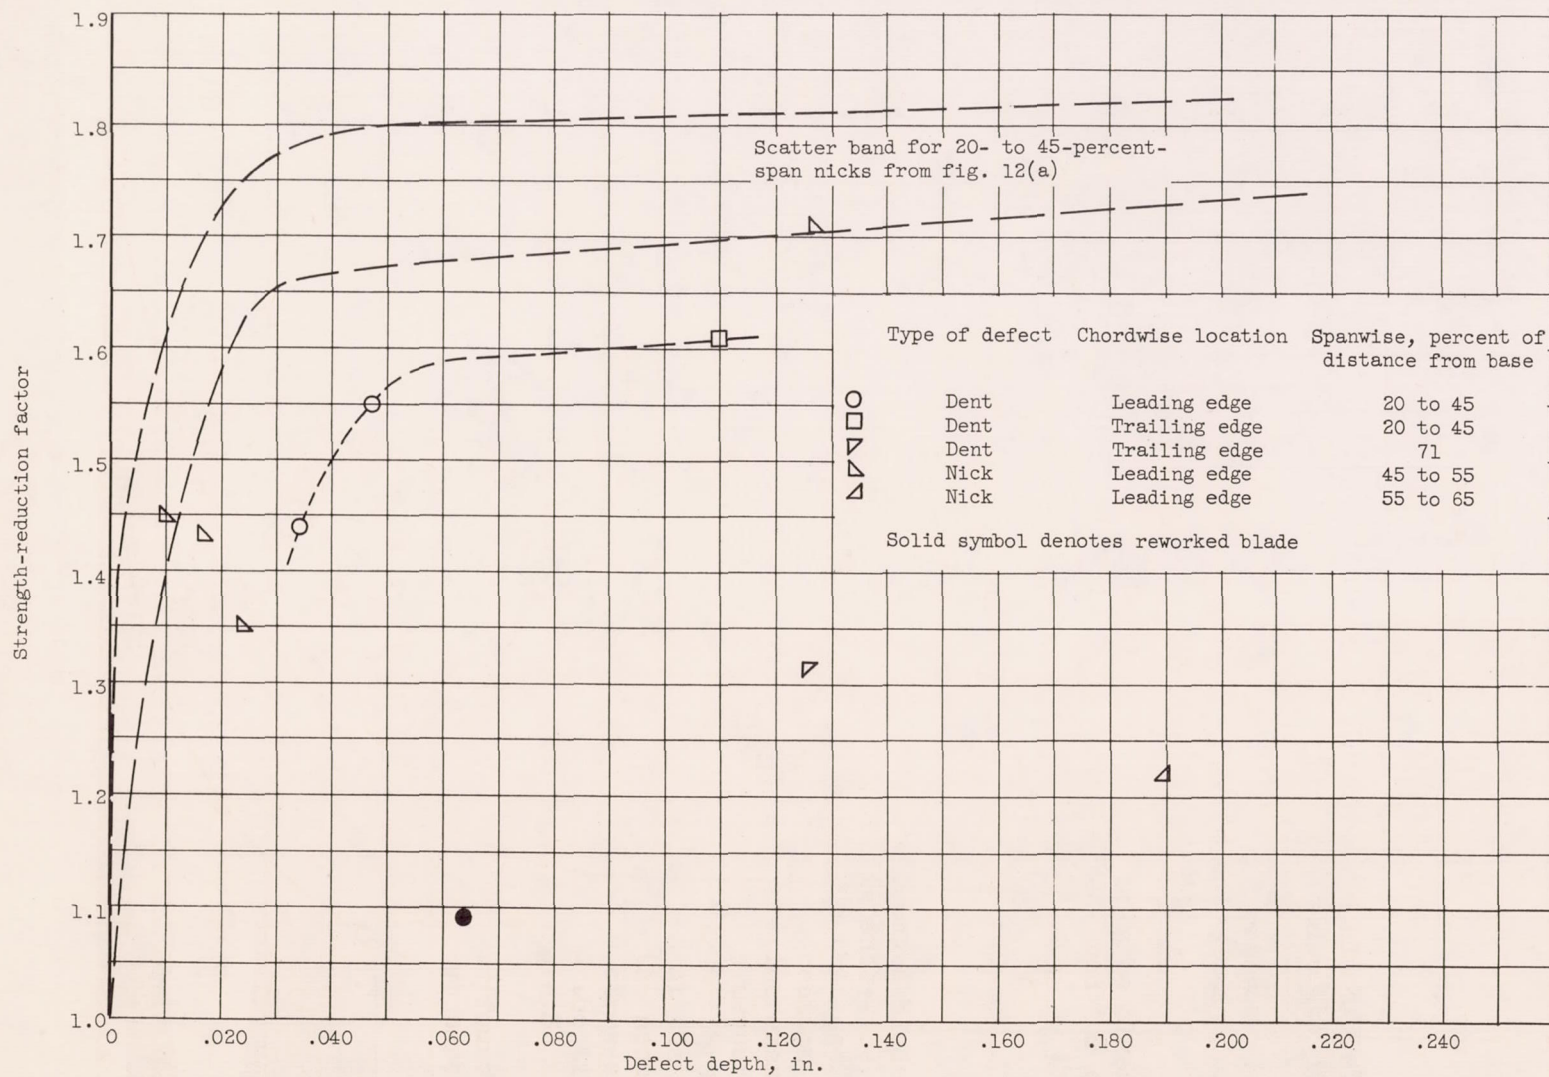
(b) Nicks outside 20- to 45-percent-span region and dents.

In figure 12(b) the effects of nicks, outside the 45-percent-span region, and of dents are shown. The strength-reduction factors for edge nicks above the 45-percent-span region either fell below or at the lower

limit of the scatter band replotted from figure 12(a). Dents, even those in the 20- to 45-percent-span region are less serious than nicks of comparable depth.

Figure 12. - Concluded. Effect of defect depth and location on strength reduction.

To find what effects, if any, reworking has in improving the strength of damaged blades, a number of fatigue tests were conducted with the nicks and dents reworked. One blade with a dent at 36 percent span on the leading edge, which might have been expected to introduce a strength-reduction factor of 1.6 from figure 12(b), was reworked by hammering the dent until the leading edge was straight. The resulting strength-reduction factor was only 1.09. A second blade with a reworked dent at the critical section on the leading edge was run at the endurance limit of the material for  $10^8$  cycles without failing.
